# Gold Standard Home Inspection Report

## 123 Your New Home, USA

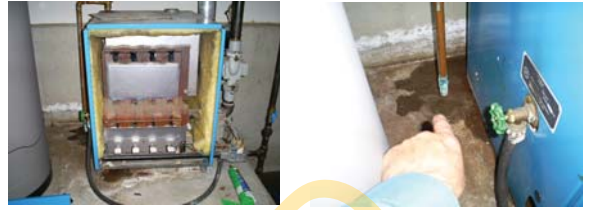
Natural gas fired hot water baseboard/radiant system. Boiler actively leaking at time of inspection. Further evaluation needed by a professional heating contractor.

Active system leakage and abnormal flame color visible-further investigation by professional heating contractor needed. Unknown remaining life of boiler. Improper type vent piping installed-upgrade to stainless steel type piping needed for safety.

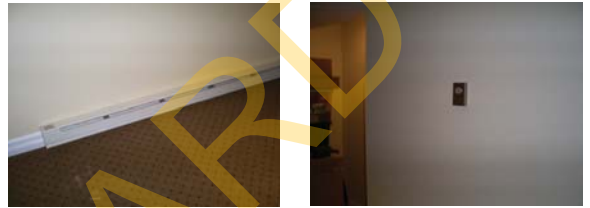
Electric baseboard heating in lower-level finished rooms have separate wall thermostats.

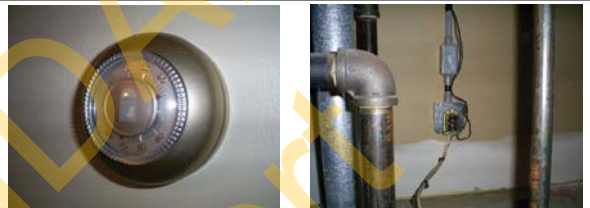
Photo shows typical thermostat for this zoned system. Improper type wiring from wall junction box to boiler-should be either in conduit or BX type

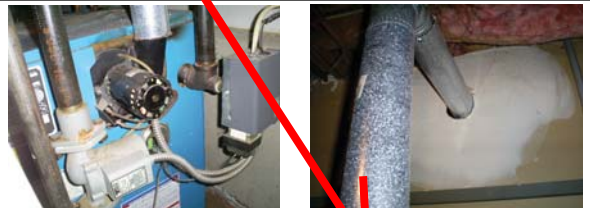
Improper type vent piping installed. Some corrosion visible at piping joints. Vent pipe upgrade needed for safety.

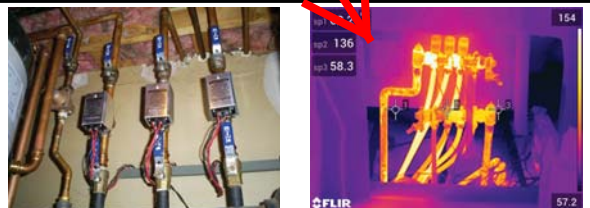
Multi-zone hot water system using both standard baseboard and radiant manifolds. Far right is infrared photo showing temperature differentials of radiant manifold piping for kitchen in floor heat.
